Field Report for Hillsboro Quarters

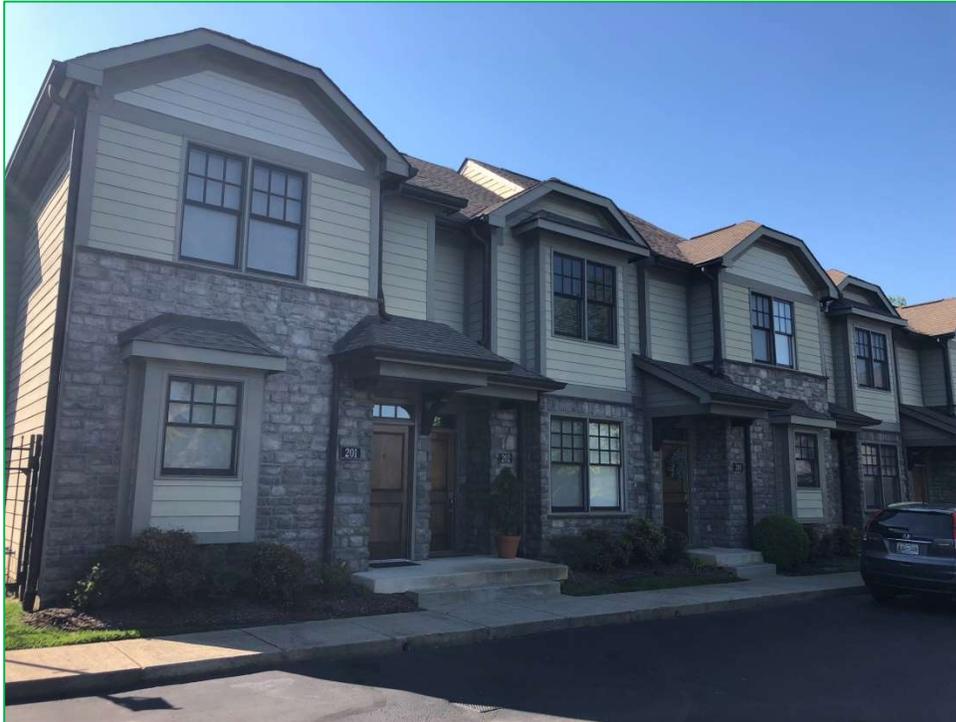
This is a view of the property that faces Hillsboro Road.

Overall the property is in good condition.

The concrete siding was generally good.

The sidewalks were in generally good condition with little cracking and decay.

Except for a few spots, the parking lot is good.

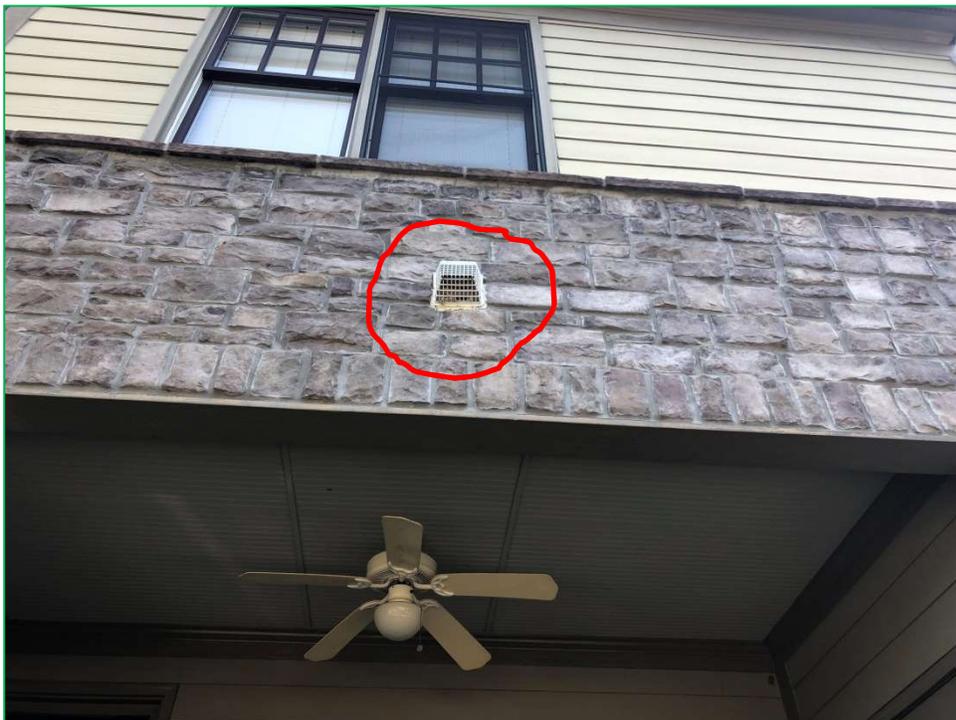
In walking around the property, it appears that several of the dryer vents have the “cage” box.

Generally the Fire Marshall does not like these type of devices as the lint can catch in cage, thereby blocking the dry vent.

This is an item to monitor.

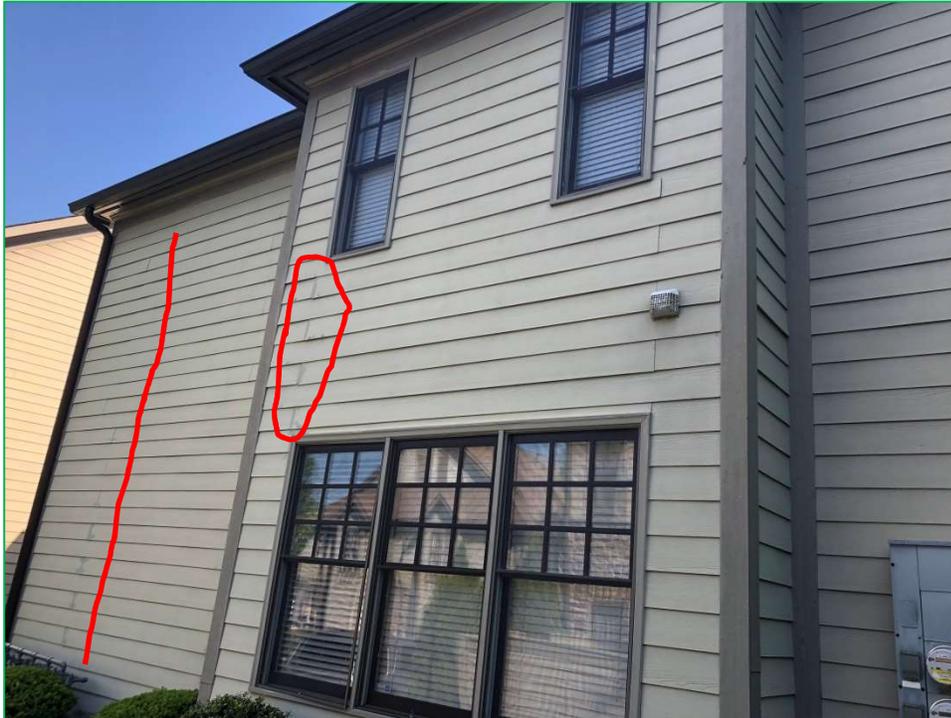
The siding on the South side (Castleman Drive) showed some signs of needed repair.

The seams were very noticeable. It appears that a prior repair may have been done with different paint color.

Also, the paint on the Southside showed the greatest amount of fading.

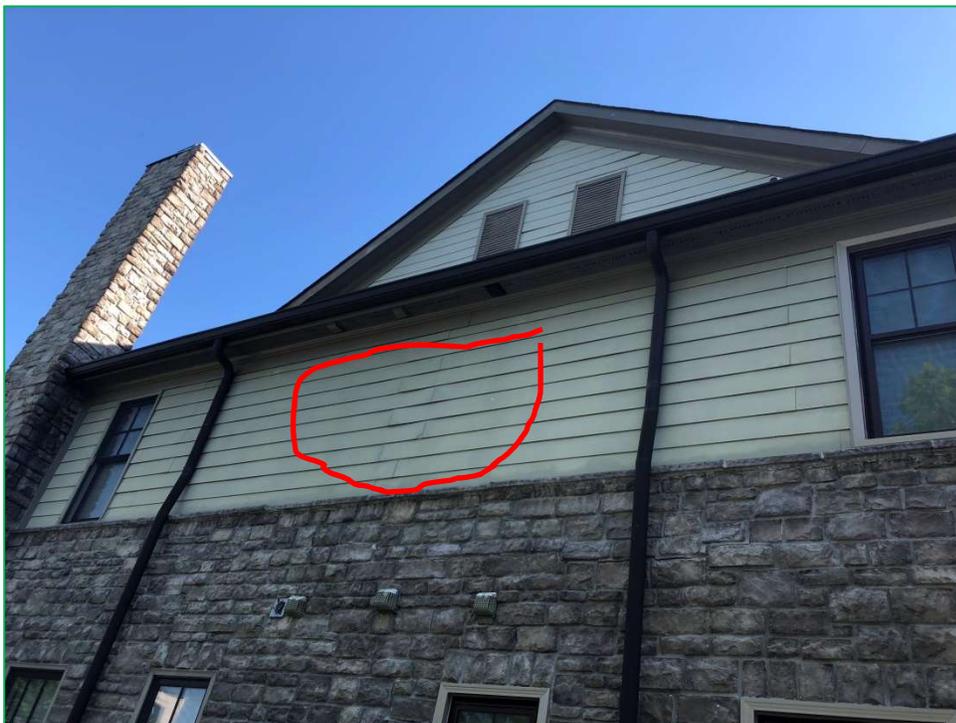
This is also on the Southside.

The paint has the greatest amount of fading than other sides observed during the visit.

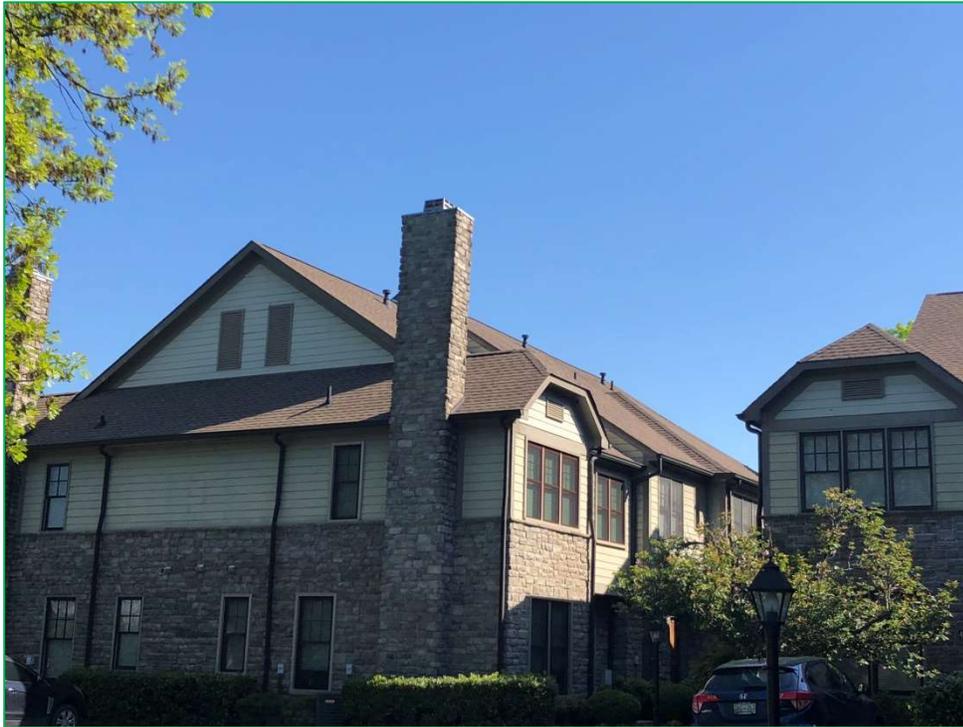
This view is taken from the street.

Except for the fading paint on the concrete siding, the rest of the building looks good.

The landscape material is in good condition. It is well pruned and maintained.

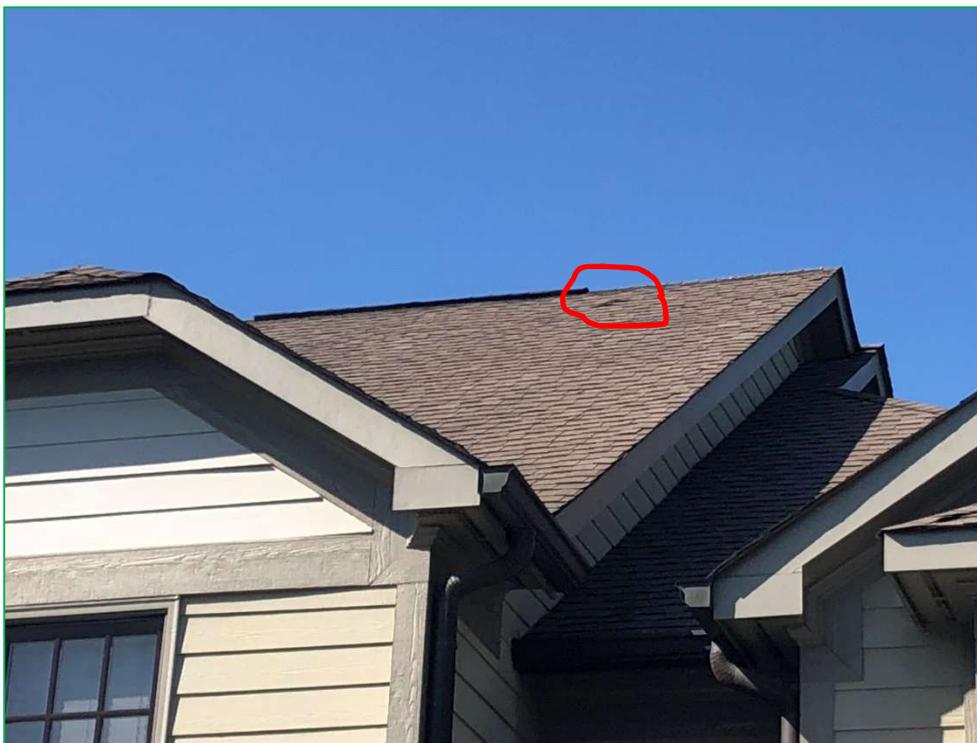
On the Hillsboro Road side of the property, there is a loose shingle near the ridge line.

Overall, the shingles looked good. Not sure of the age of the shingles but a roof evaluation may be a good idea to determine condition and remaining life.

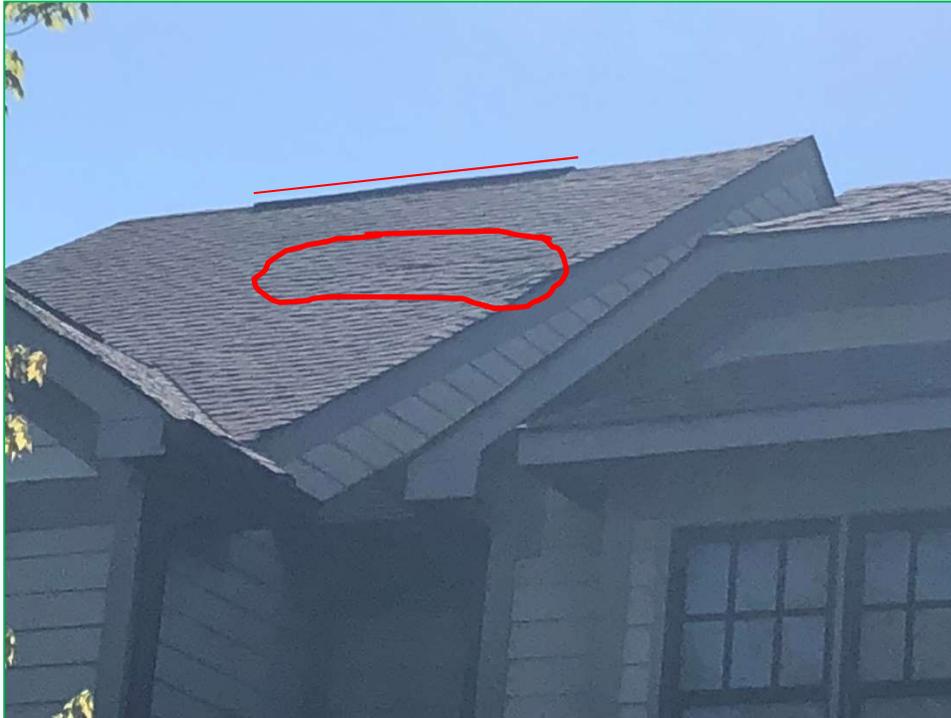
This is on the southside building off of the Hillsboro Road entrance.

There may be a little lifting occurring with the shingle.

The redline is above the ridge vent. To ensure proper ventilation, the ridge vents generally extend further to each end. A roof evaluation would reveal.

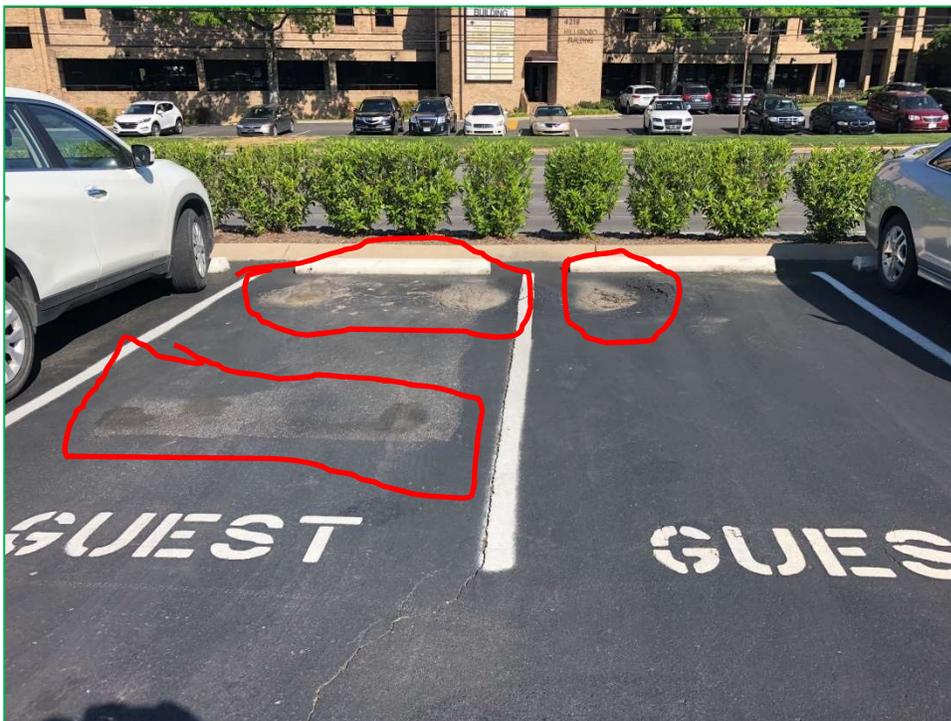
This section of the parking lot had significant indentation. That is typically seen in front of a dumpster or where heavy trucks traffic.

Based on the repair to the left, this may be an area with water issues.

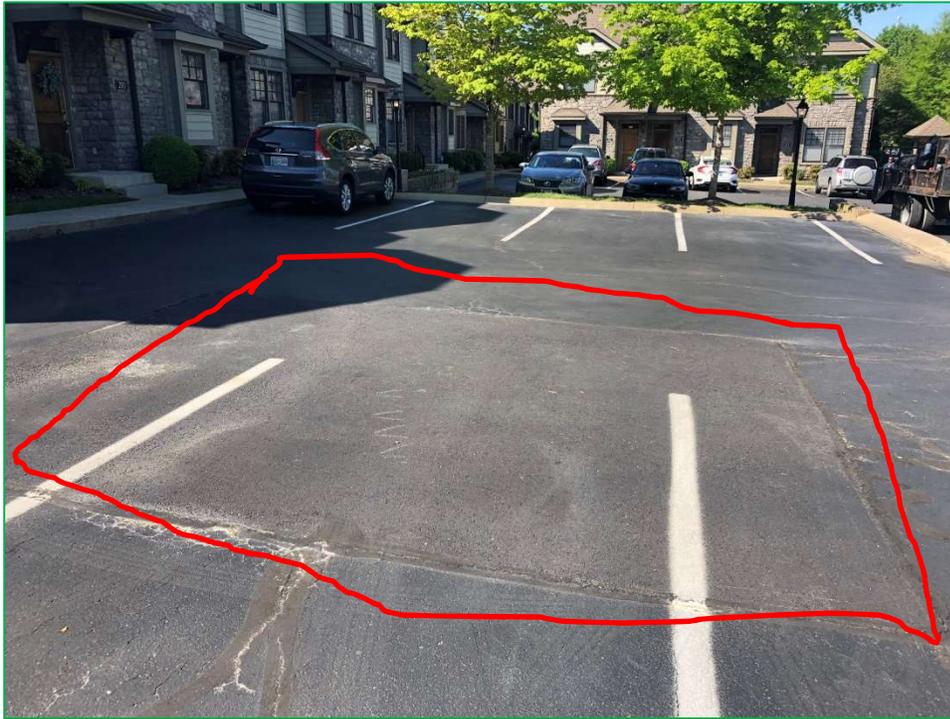
A significant repair has been performed here.

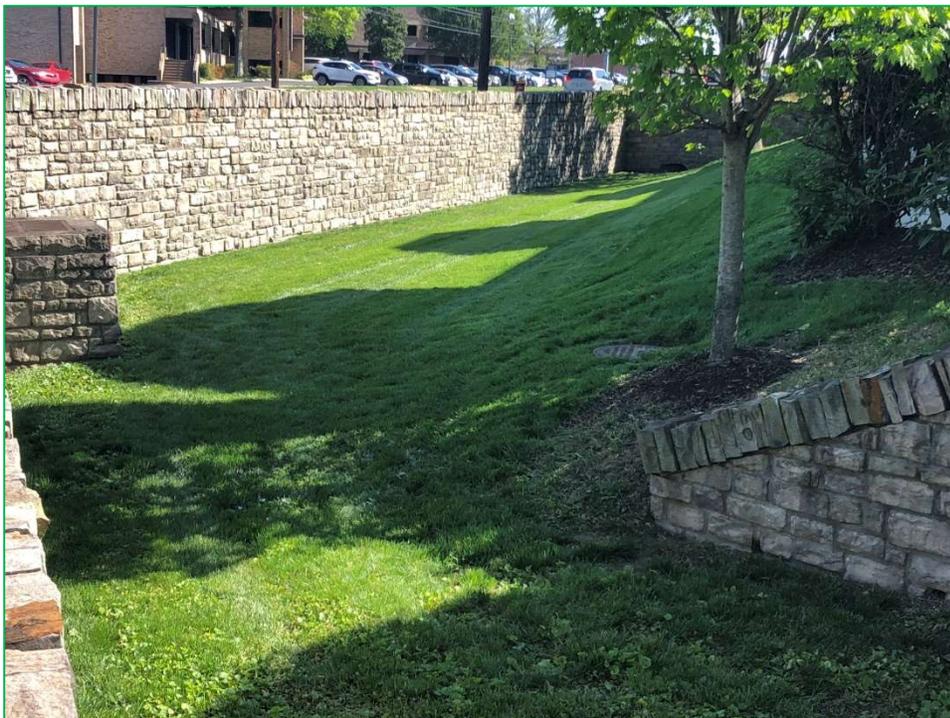
The grounds were in good condition. All of the stone walls appear to be in good condition.

This is one of the detention ponds on the property.
